# Silver dendrite formation during damp heat test on Exxelia SFC 035 feedthrough filters

Edition: 1  
Date: 12/01/2023  
Status: OPEN

<p><b>EXXELIA</b></p> <p><b>1 RUE DES TEMPS MODERNES</b> <b>77600 CHANTELOUP-EN-BRIE</b> <b>FRANCE</b></p>	<p><b>FAMILY :</b> CAPACITOR FILTER</p> <p><b>SUB-FAMILY :</b> FEEDTHROUGH</p> <p><b>TYPE :</b> SFC 035 3471 YR 100V</p> <p><b>PART NUMBER :</b> 300803102C471ME</p> <p><b>LOT DATE CODE :</b> ALL SINCE 2031</p>
--------------------------------------------------------------------------------------------------------------------	-------------------------------------------------------------------------------------------------------------------------------------------------------------------------------------------------------------------

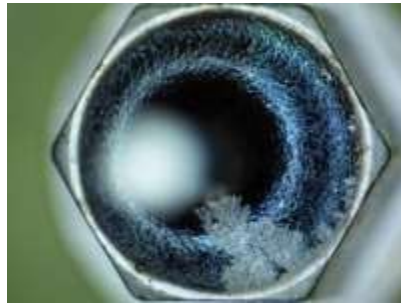
During LAT2/Damp heat test, Exxelia observed the formation of silver dendrites on the body of the filter which progresses towards the central contact on several parts:

Several investigations are in progress (environmental conditions at Exxelia, influence of exposure angle and position in the oven during damp heat testing, influence of the obstruction resin profile ...) but no root cause was identified at this stage.

The non-qualified silver variants shall not be used, it is recommended for users to favour ESCC qualified products with gold finish (SFC030).
